**Flood Control Project Maintenance
Levee Inspections**

Maintenance Issue Types Only, Levee Inspection Report By Mile - Spring 2019

Sutter Maintenance Yard Maintenance Area 0003

Waterway	Bank	Unit Miles	Inspection Start/End	Inspector
Unit No. 01 Feather River	Right	5.11	04/24/2019 04/24/2019	Sterling York

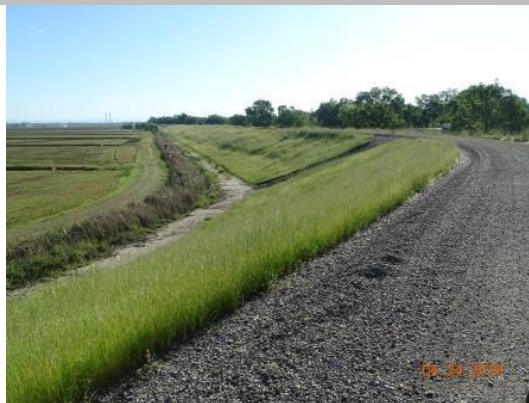
Photo 1 of 1 : SP_2019_MA0003_195_8_20190429_00017.jpg

LM Start	0.01	Rating **	M	Issue No.	8
LM End	5.10	Issue Type +	Ma	Location *	LS
Category	Earthen Levee			GPS Latitude/Longitude	
				Start	End
Item	Vegetation			38.897983 °	38.950817 °
				-121.617871 °	-121.585816 °
DWR ID	DWR_MA0003_01_s_2019_8				
Comment Code					
V1 : Control annual grass and weeds on the levee slopes and easements.					
Inspector Comment					
The annual vegetation needs to be maintained, Spring 2019.

View looking upstream landside at the annual vegetation that needs to be maintained, Spring 2019.

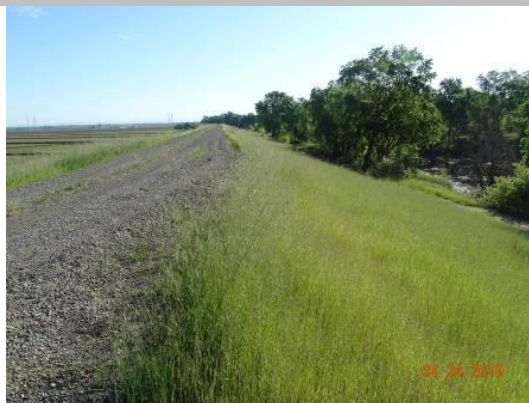
Photo 1 of 1 : SP_2019_MA0003_195_9_20190429_00018.jpg

LM Start	0.01	Rating **	M	Issue No.	9
LM End	5.10	Issue Type +	Ma	Location *	WS
Category	Earthen Levee			GPS Latitude/Longitude	
				Start	End
Item	Vegetation			38.897982 °	38.950817 °
				-121.617871 °	-121.585816 °
DWR ID	DWR_MA0003_01_s_2019_9				
Comment Code					
V1 : Control annual grass and weeds on the levee slopes and easements.					
Inspector Comment					
The annual vegetation needs to be maintained, Spring 2019.

View looking upstream waterside at the annual vegetation that needs to be maintained, Spring 2019.

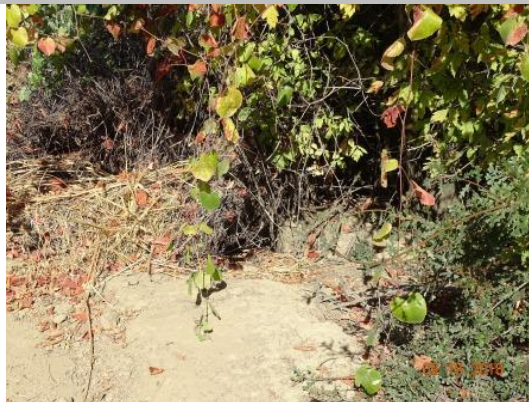
Photo 1 of 1 : SP_2019_MA0003_195_17_20190305_00001.jpg

LM Start	0.69	Rating **	M	Issue No.	17
LM End	0.69	Issue Type +	Ma	Location *	LS
Category	Earthen Levee			GPS Latitude/Longitude	
				Start	End
Item	Animal Control			38.903352 °	38.903352 °
				-121.607829 °	-121.607829 °
DWR ID	DWR_MA0003_01_s_2017_17				
Comment Code					
A1 : Exterminate rodents and backfill and compact or grout burrows.					
Inspector Comment					
There is an existing animal hole that is on the outside edge of the landside patrol road and does not appear to have any recent animal activity. It is not effecting the levee prism but it should be backfilled and monitored.

View of animal activity on landside levee patrol road, Spring 2019.

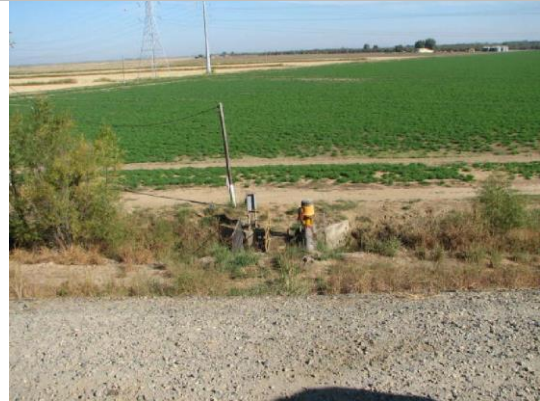
Photo 1 of 3 : UCIP_SP_2019_53921_64649.jpg

FS_ID:53921
DS_ID:17092
EP_NO: N/A
Repair Type: Urgent
Crossing Status: Found
UCIP Comments: 05/01/2019 (O. Magana - DWR UCIP)10/04/2018 Sink hole observed between the dual 18-inch pipes located on the LS near the concrete headwall. Erosion was also observed behind the concrete headwall located on the LS. Inlet of dual 18-inch pipes was still covered by filled sandbags. Crossing remains Urgent due to the sink hole and erosion visible on the LS. These crossings were recommended for replacement under the SBFCA project; however, no work has been done to date. Recommend monitoring site and coordinating with SBFCA to determine the status of the project. (O. Magana - DWR UCIP)
04/11/2017 Water levels were high on WS during inspection so pipe ends could not be inspected. Believe that the sandbags are stil in place and condition of flap gates is unknown. (DWR Sutter Yard - A Freitag)10/10/2016 WS pipe end was underwater for inspection but the sandbags still appear to be in place. (DWR Sutter Yard - a Freitag)04/18/2016 No repairs have been made to the pipe yet. (DWR Sutter Yard - a Freitag)05/12/2015 Water level high in WS ditch so could not see WS end of crossing. Do not believe that repairs have been made yet. (DWR Sutter Yard - a Freitag)11/17/2014 Same as last inspection. (DWR Sutter Yard - a Freitag)05/14/2014 Same as last inspection. (DWR Sutter Yard - a Freitag)10/30/2013 Same as last inspection. (DWR Sutter Yard - a Freitag)05/21/2013 SBFCA project recommends replacing in accordance with title 23. High water levels in WS ditch have pipe ends underwater but repairs have not yet been completed but are planned for when water levels drop. (DWR Sutter Yard - a Freitag)10/10/2012 Flap gates not visible on waterward headwall and it appears as though they have been replaced by sandbags. Slide gates on LS appear to be closed yet water leaks excessively from the WS at the sandbagged headwall. (DWR UCIP - W. Wylie)

Concrete headwall with walkway and slide gates at LS toe.

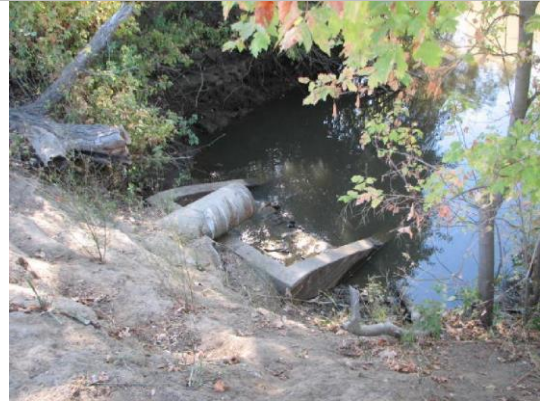
Photo 2 of 3 : UCIP_SP_2019_53921_64648.jpg

Concrete U shaped headwall on WS toe filled in with Sandbags. 16-inch pipe shown over top of headwall.

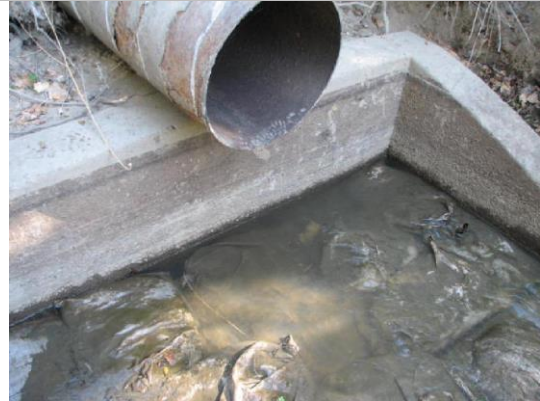
Photo 3 of 3 : UCIP_SP_2019_53921_64647.jpg

Concrete U shaped headwall filled in with sandbags on WS toe. Flap gates appear to be missing and water readily flows through the sandbags from LS.

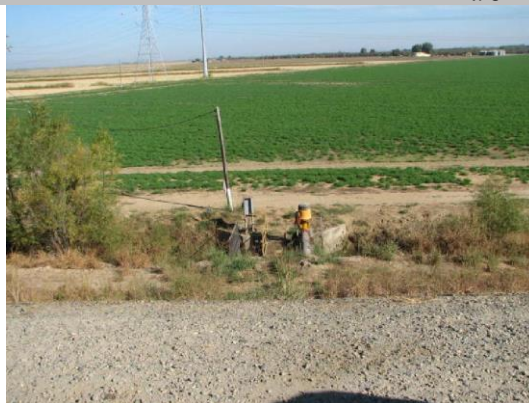
Photo 1 of 3 : UCIP_SP_2019_53922_64662.jpg

Sink hole observed between the dual 18-inch pipes located on the LS near the concrete headwall. Erosion was also observed behind the concrete headwall located on the LS. Inlet of dual 18-inch pipes was still covered by filled sandbags. Crossing remains Urgent due to the sink hole and erosion visible on the LS. These crossings were recommended for replacement under the SBFCA project; however, no work has been done to date. Recommend monitoring site and coordinating with SBFCA to determine the status of the project. (O. Magana - DWR UCIP)

Concrete headwall, slidegates, and metal walkway on LS toe.

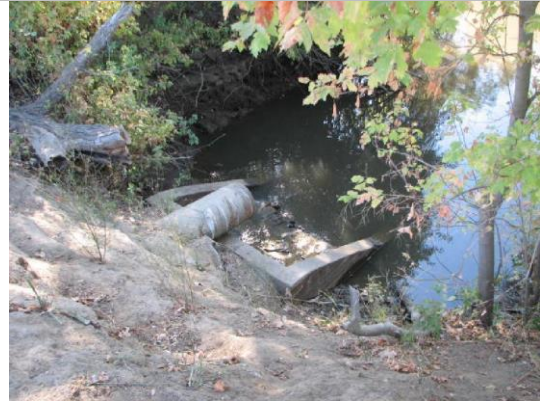
Photo 2 of 3 : UCIP_SP_2019_53922_64661.jpg

Concrete U shaped headwall on WS toe filled with sandbags.

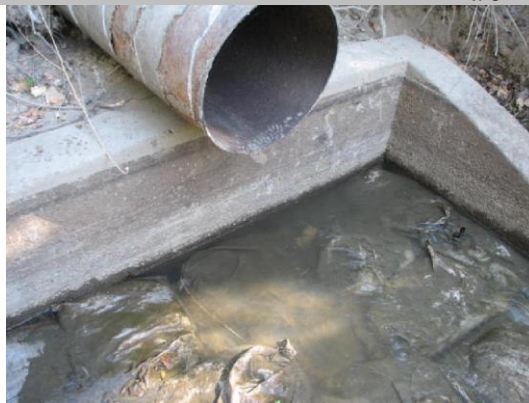
Photo 3 of 3 : UCIP_SP_2019_53922_64660.jpg

Flap gates appear to be missing from U shaped headwall. Sandbags fill headwall but water flows heavily from LS.
